WALL PANEL SYSTEMS, INC. MIAMI-DADE TEST REPORT

ASTM E330 STRUCTURAL WIND LOAD TESTING, TAS 202 (LOADS ONLY) AND TAS 203 TESTING ON WPS HORIZONTAL FLUSH SIDING SYSTEM

M8125.03-303-44 R4

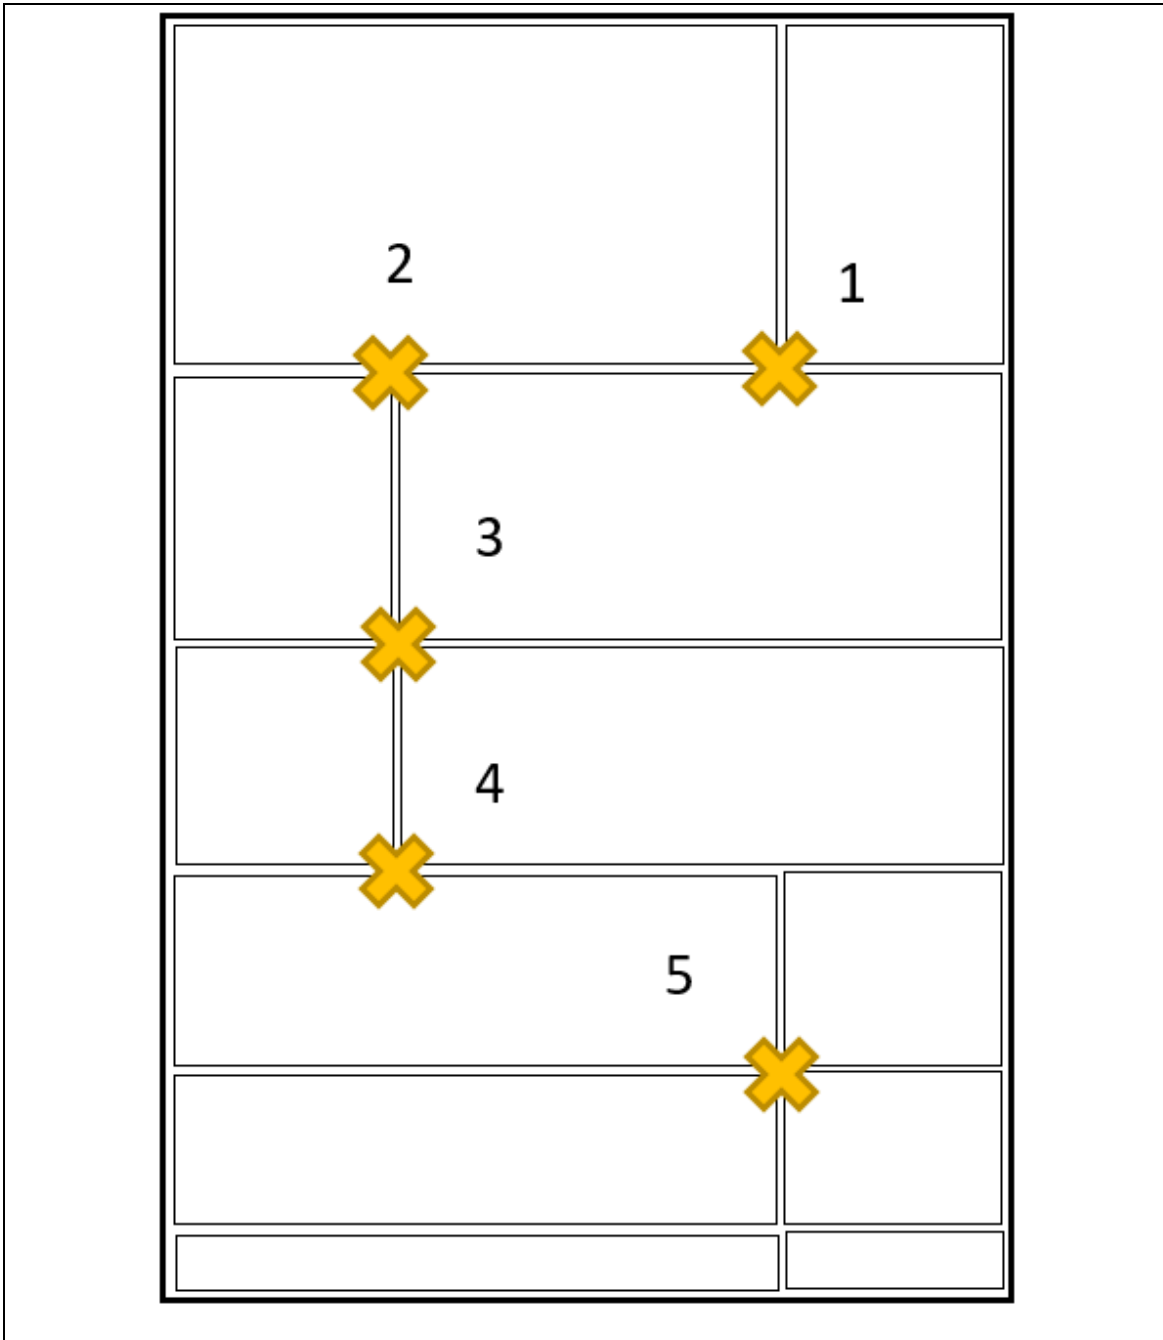
Sketch No. 1

TAS 202 Indicator Locations for deflection/perm. Set

LOAD (psf)	INDICATOR LOCATION	DEFLECTION (in.)		PERMANENT SET (in.)	
		MEASURED	ALLOWED	MEASURED	ALLOWED
+75.00 Design Pressure	1	0.04	N/A	<0.01	N/A
	2	0.07	N/A	<0.01	N/A
	3	0.03	N/A	<0.01	N/A
	4	0.02	N/A	<0.01	N/A
	5	0.05	N/A	<0.01	N/A
-75.00 Design Pressure	1	0.21	N/A	0.02	N/A
	2	0.37	N/A	0.02	N/A
	3	0.31	N/A	0.03	N/A
	4	0.01	N/A	<0.01	N/A
	5	0.36	N/A	<0.01	N/A

LOAD (psf)	INDICATOR LOCATION	DEFLECTION (in.)		PERMANENT SET (in.)	
		MEASURED	ALLOWED	MEASURED	ALLOWED
+112.5 1.5 x Design Pressure	1	0.13	N/A	<0.01	N/A
	2	0.14	N/A	<0.01	N/A
	3	0.10	N/A	<0.01	N/A
	4	0.08	N/A	<0.01	N/A
	5	0.15	N/A	<0.01	N/A
-112.5 1.5 x Design Pressure	1	0.35	N/A	0.02	N/A
	2	0.44	N/A	0.03	N/A
	3	0.38	N/A	0.02	N/A
	4	0.16	N/A	0.05	N/A
	5	0.46	N/A	0.01	N/A

Note 3: See Sketch #1 for indicator locations. Deflection/permanent set reported is the overall deflection between three points (longest unsupported span) which accounts for support movement.

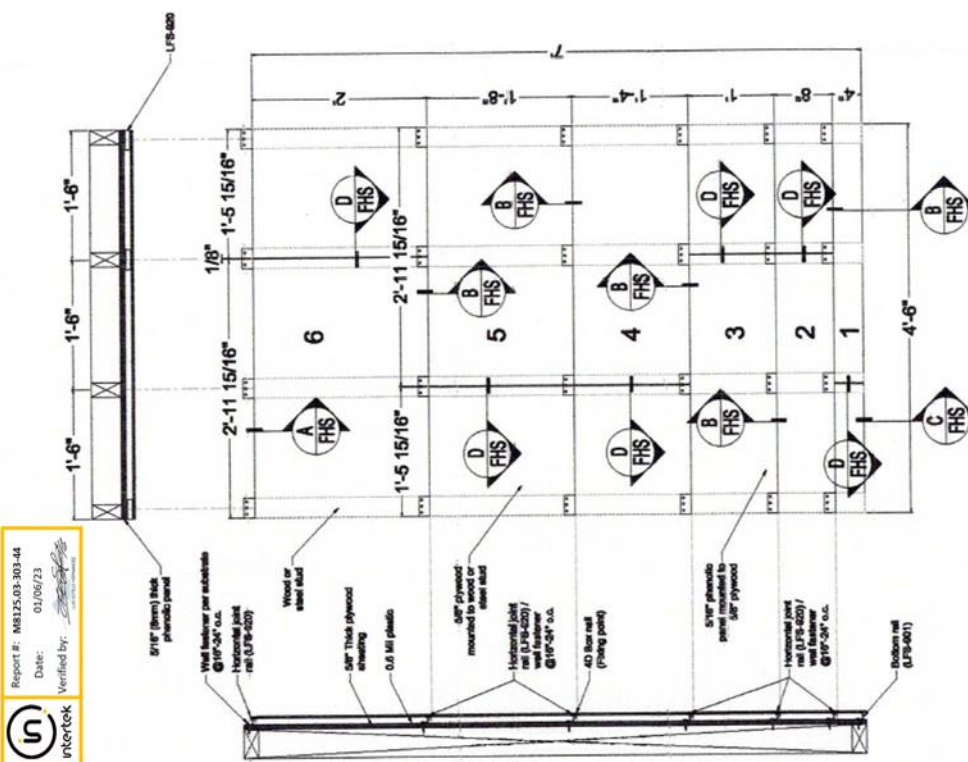
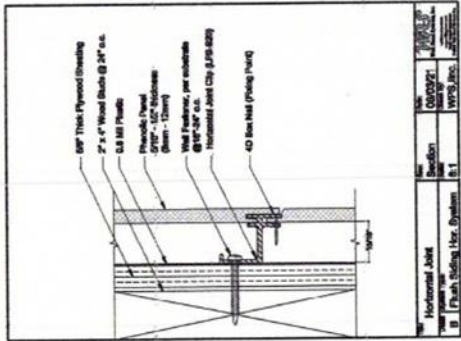
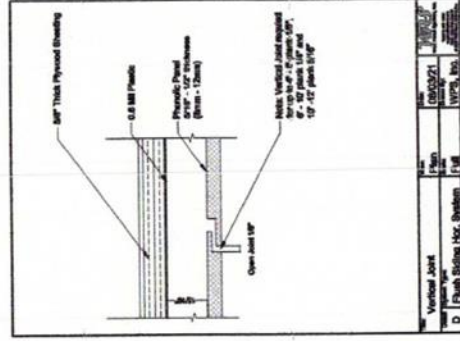
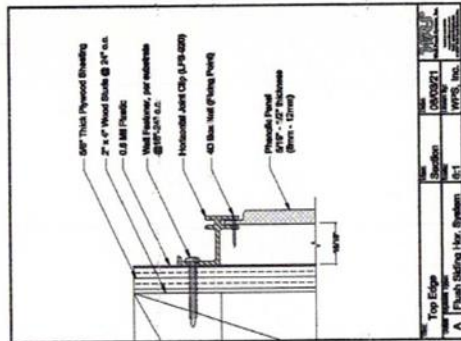
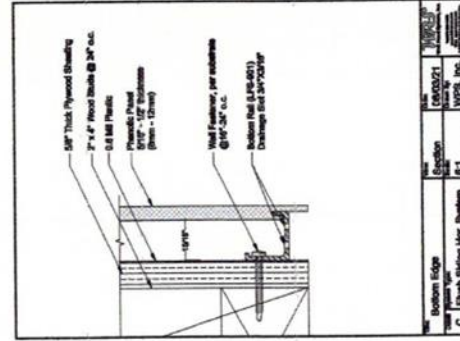
WPS HORIZONTAL FLUSH SIDING SYSTEM For TAS 202 & 203

The test specimen drawings have been reviewed by Intertek B&C and are representative of the test specimen(s) reported herein. Test specimen construction was verified by Intertek B&C per the drawings included in this report. Any deviations are documented herein or on the drawings.
